Nondestructive Testing to Identify Delaminations Between HMA Layers, Volume 5 - Field Core Verification

**SHRP 2 REPORT S2-R06D-RW-5**

Nondestructive Testing to Identify Delaminations Between HMA Layers

Volume 5

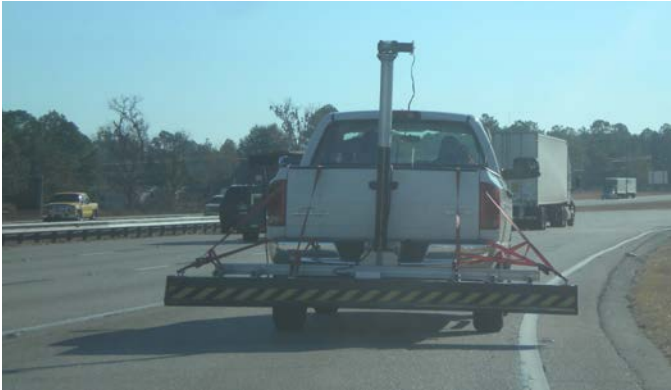
Figure 1.1. 3d-Radar equipment used for field tests.

Field testing of the 3d-Radar ground-penetrating radar (GPR) system was carried out at sites in Florida, Kansas, and Maine. The equipment configuration used for this testing is shown in Figure 1.1. The data were collected at 3 nominal speeds: 40 mph, 20 mph, and 5 mph, and the level of detail of the data increased as the speed was lowered. The data analysis was carried out on the lowest-speed data, because these data had the highest level of detail. This data collection was carried out on a smaller section of pavement that was selected to most likely include delaminations. The selection of the test area was based on a review of the higher-speed data, on observation of surface distress, and on core data available from previous testing conducted by the corresponding state department of transportation.

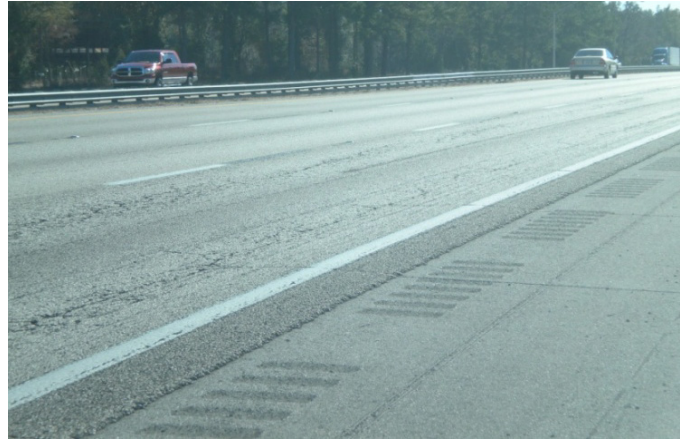
Figure 1.2. Pavement conditions between MP 413 and rest area.

The section selected for a more detailed analysis was based on a review of the three-dimensional (3-D) GPR data and on the observed surface conditions. The focus was on the southbound section, particularly the segment between Milepost (MP) 413 and the southbound rest area entrance. Surface distress observed in this area suggests some moisture damage in the layers below. See Figure 1.2.

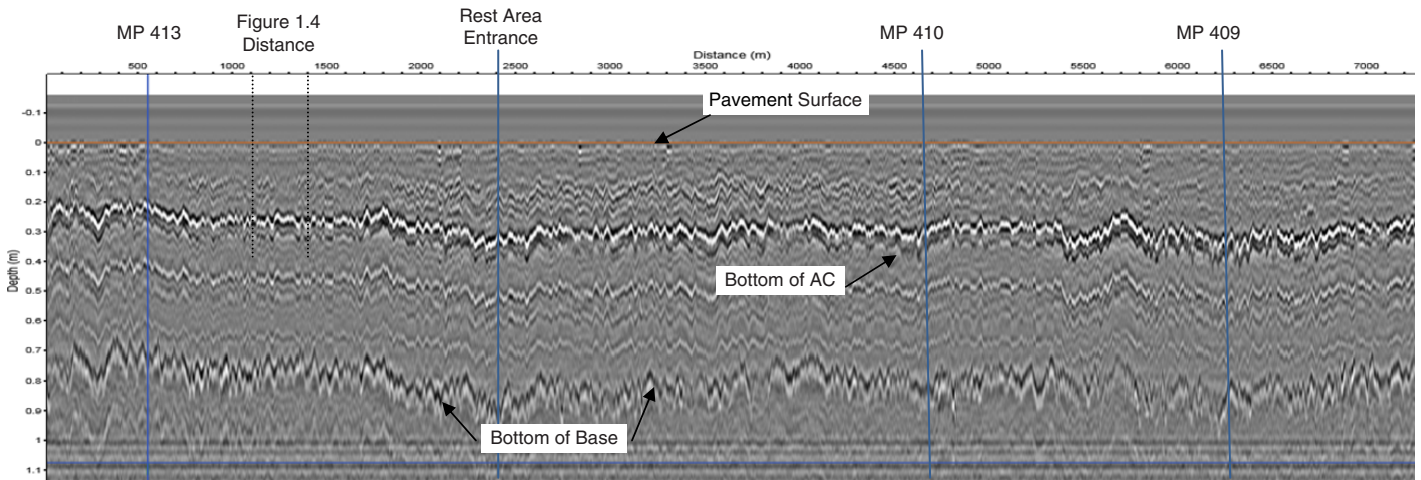
Figure 1.3. Overview of 20-mph GPR data for I-75 southbound (centerline).

Figure 1.3 shows an overview of the GPR layer structure data for this southbound region. The section is fairly homogeneous, but it appears that the overall asphalt thickness is lower in the segment north of the rest area. Figure 1.4 shows local detail of the pavement cross section. Note that what appears to be the ARMI layer is evident periodically in the GPR data structure. It is possible that if this layer is impermeable, a layer boundary will appear in the GPR data where moisture has been retained. On the basis of a qualitative review of the depth slice data, it was recommended that the mechanical wave testing be carried out on a 2,000-ft-long section that began 2,000 ft south of MP 413.

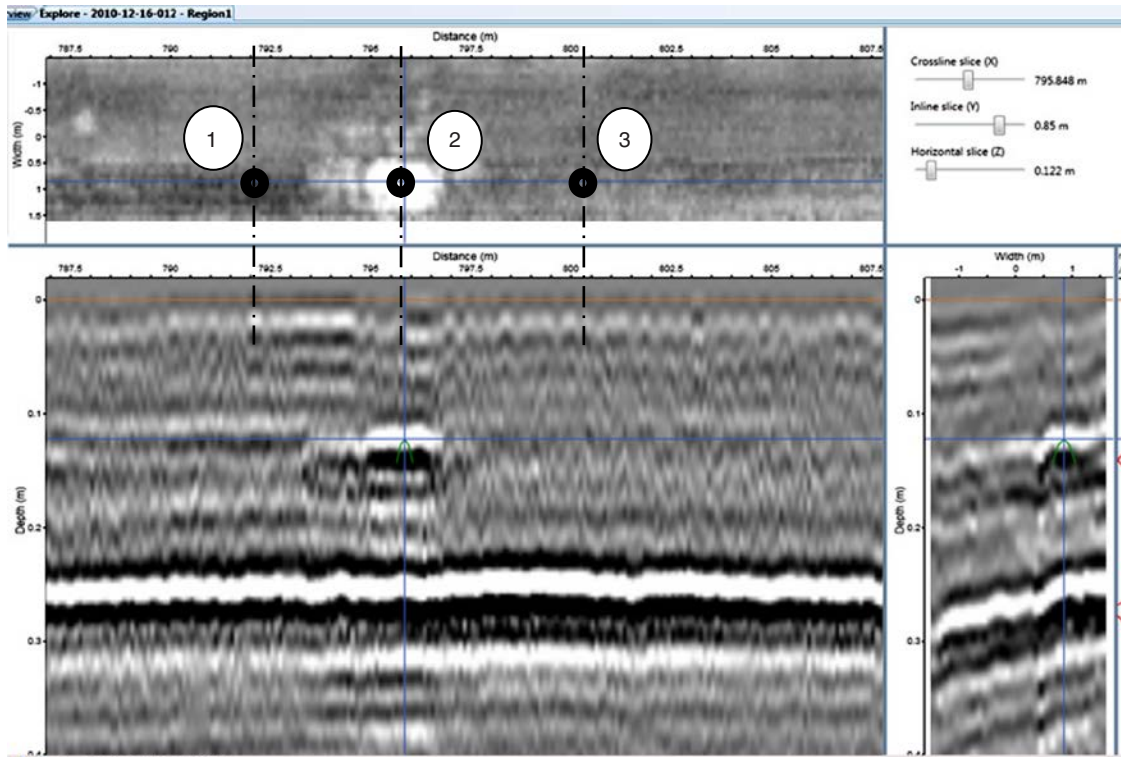
Figure 1.5. Core locations 1, 2, and 3.

Figures 1.5, 1.6, 1.7 and 1.8 show the core locations superimposed on the GPR horizontal slice and profile data. The top figure is the horizontal (depth) slice, the bottom left figure is the longitudinal profile, and the bottom right figure is the transverse profile. The numbers in circles are the core numbers. Figure 1.9 shows the automated activity analysis for the Gainesville site. The likelihood of distress is color coded. The location of each core was added to the analysis.

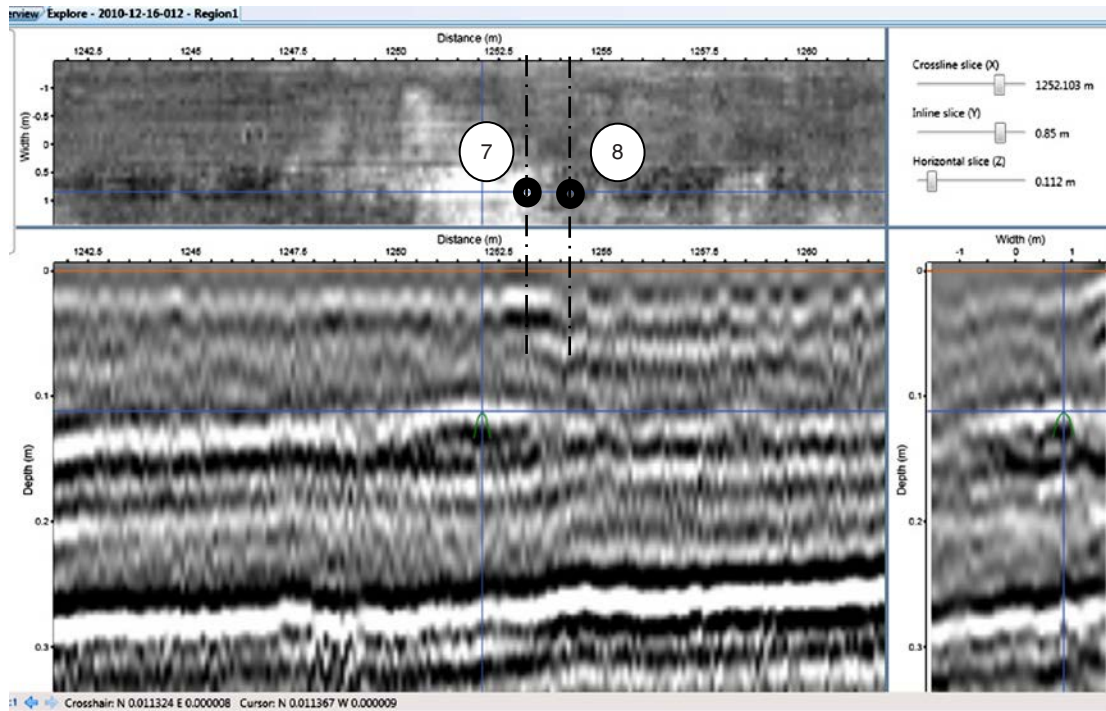
Figure 1.7. Core locations 7 and 8.

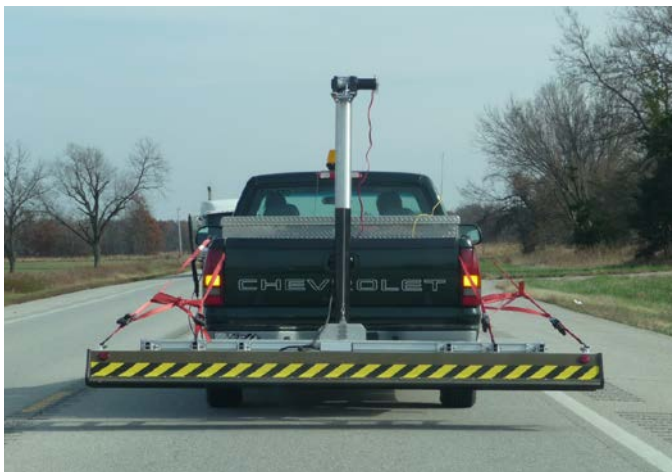
Figure 3.1. 3d-Radar equipment used for field tests.

Field testing of the 3d-Radar ground-penetrating radar (GPR) system was carried out at sites in Florida, Kansas, and Maine. The equipment configuration used for this testing is shown in Figure 3.1. The data were collected at 3 nominal speeds: 40 mph, 20 mph, and 5 mph. The level of detail of the data increased as the speed was lowered. The data analysis was carried out on the lowest-speed data, because these data had the highest level of detail. This data collection was carried out on a smaller section of pavement that was selected to most likely include delaminations. The selection of the test area was based on a review of the higher-speed data, on observation of surface distress, and on core data available from previous testing conducted by the corresponding state department of transportation.

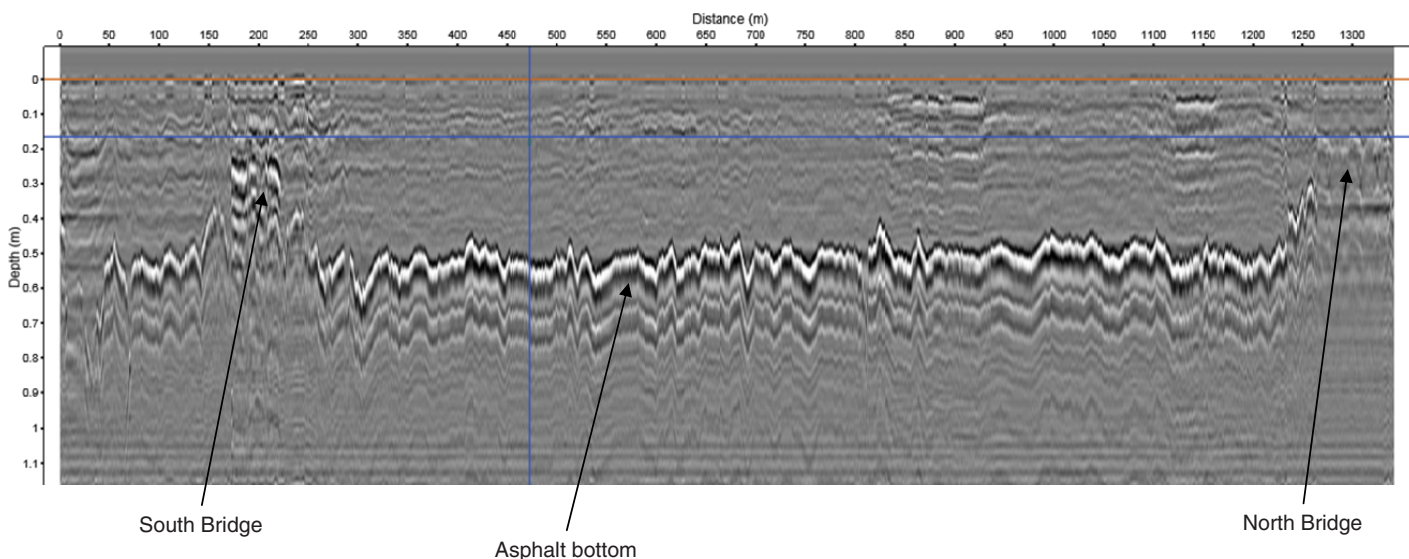
Figure 3.3. Centerline GPR data collected at 5 mph between MP 417 and MP 417.8.

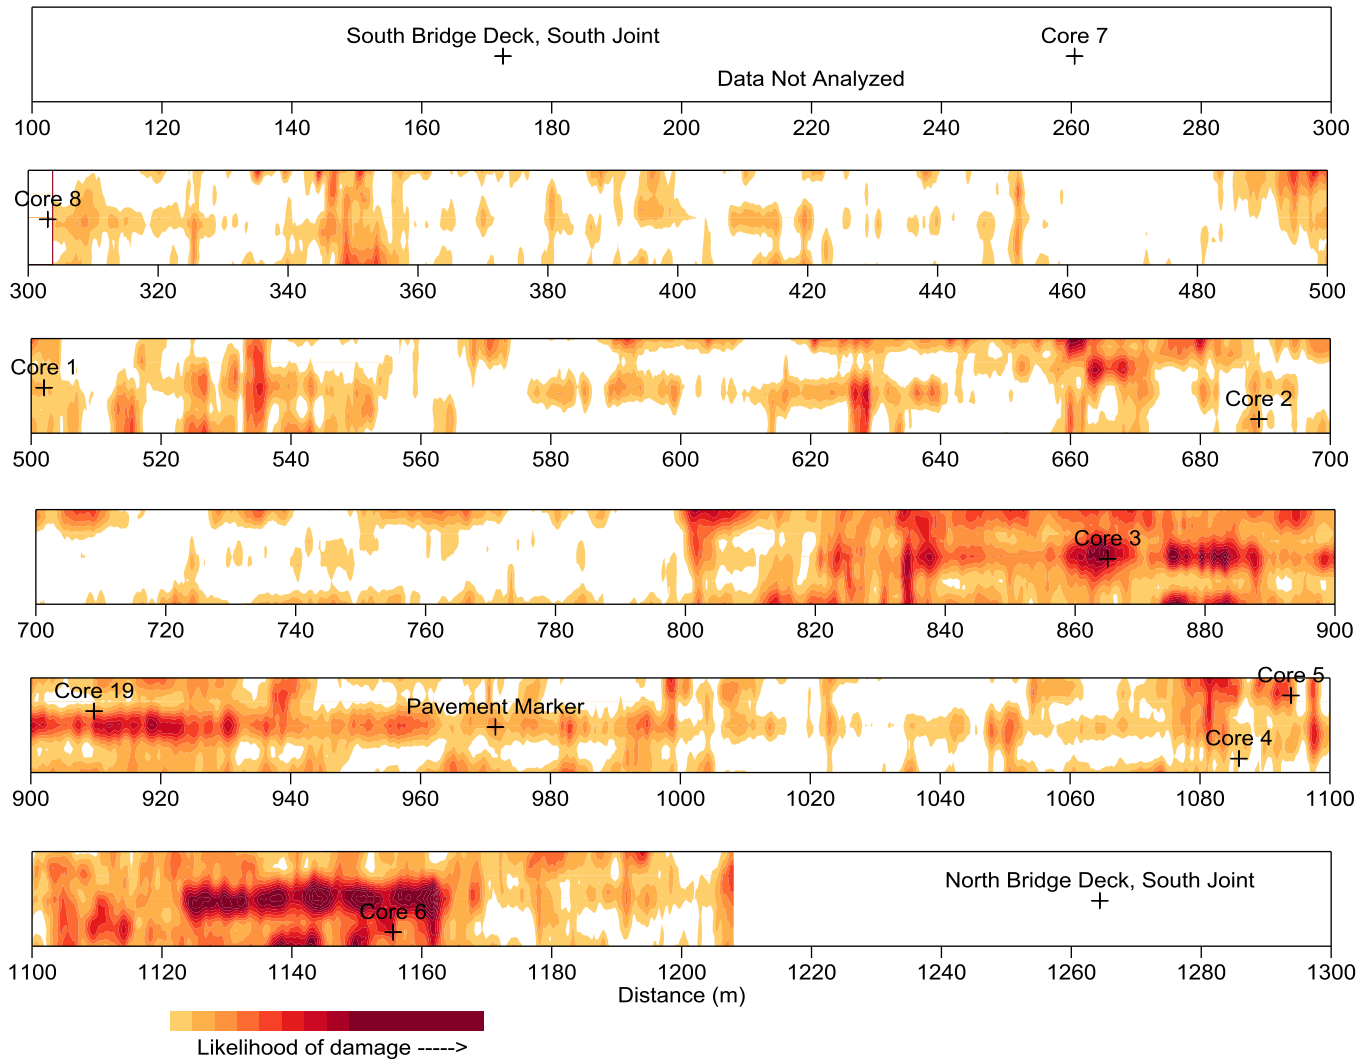
Figure 3.6. Results of automated activity analysis (see Volume 1, Chapter 3, Uncontrolled Field Evaluation section).

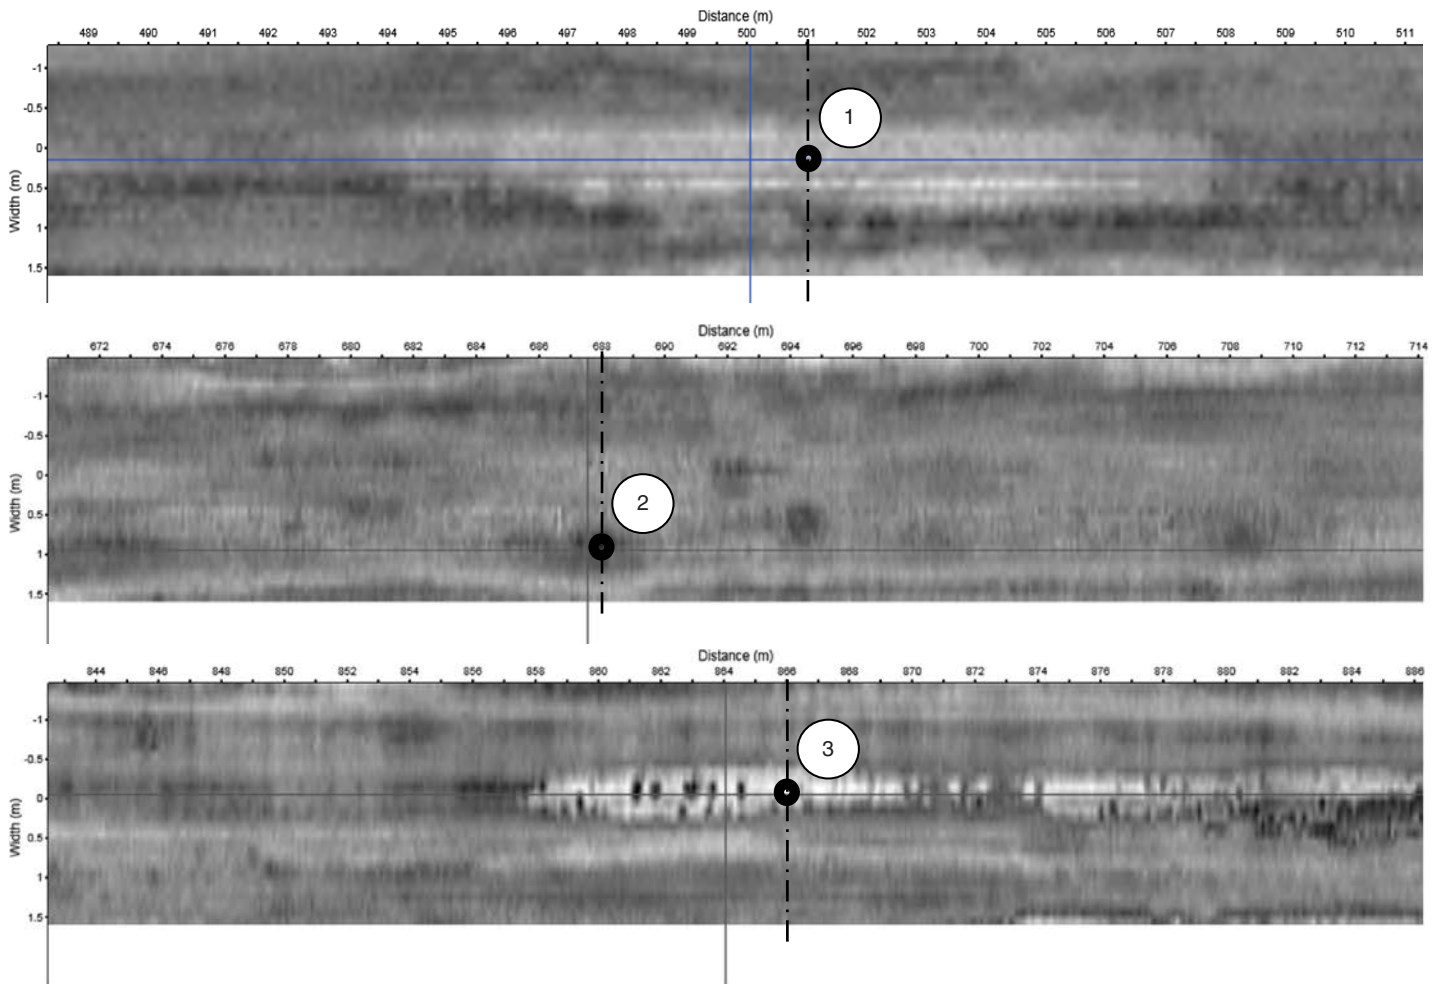
Figure 4.1. Locations of Cores 1, 2, and 3.

Table 4.1 shows the locations where anomalies were found in the GPR results and where cores were extracted in the 3,500-ft pavement site starting from MP 417.1. Figures 4.1 and 4.2 show the anomalies and the locations of the first six cores in conjunction with the NDT test results. All the cores cut from the short section broke at a depth of between 1.75 and 4.75 in. from the surface, and the base layer had a severe stripping problem. Figure 4.3 shows that Core 6 broke during coring and had severe stripping problems in the lower layers.

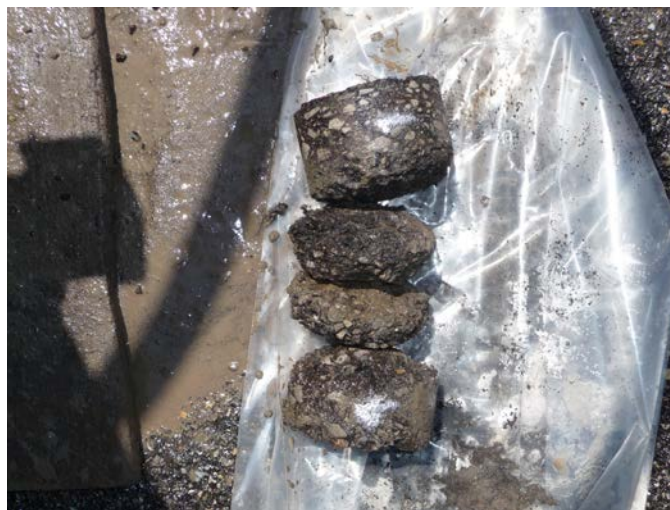
Figure 4.3. Severe stripping problems in Core 6.
