Nondestructive Testing to Identify Delaminations Between HMA Layers, Volume 1 - Summary

SHRP 2 REPORT S2-R06D-RR-1

Nondestructive Testing to Identify Delaminations Between HMA Layers

Volume 1

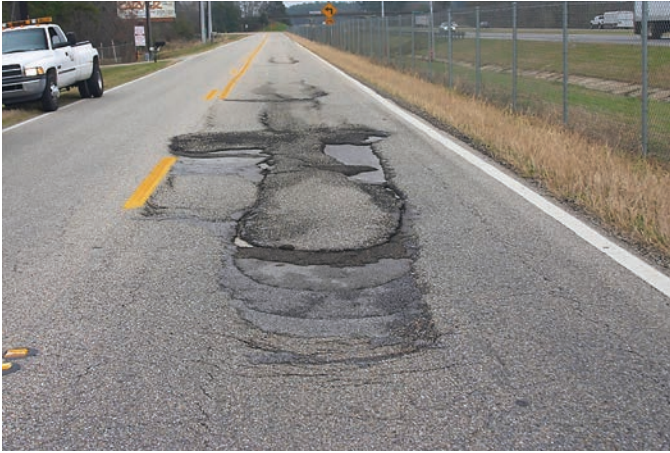
Figure 1.1. Slippage failure due to poor bond between HMA layers.

Slippage (Figure 1.1) is a visible indicator of inadequate bonding between an asphalt wearing course and its binder layer in pavements where high horizontal stresses occur. This distress develops in areas where braking, accelerating, or turning wheels move and deform the surface layer of the HMA structure (West, Zhang, and Moore 2005; Romanoschi and Metcalf 2001a). Slippage can be seen on the pavement surface in the form of half-moon-shaped cracks with the ends pointing toward the traffic direction.

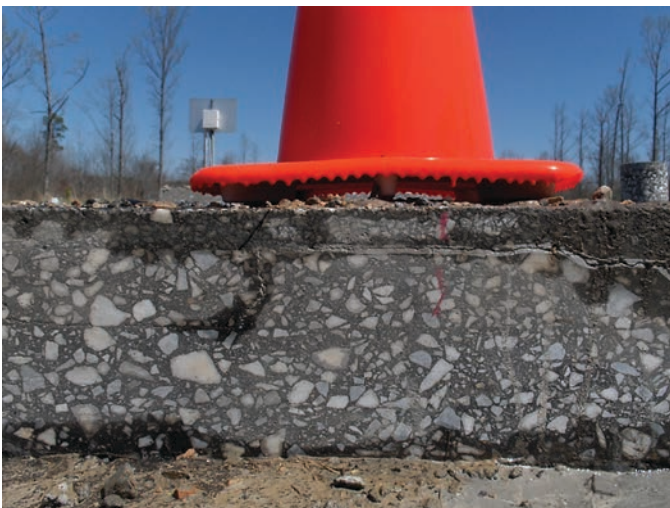
Figure 1.2. Delamination in an HMA pavement.

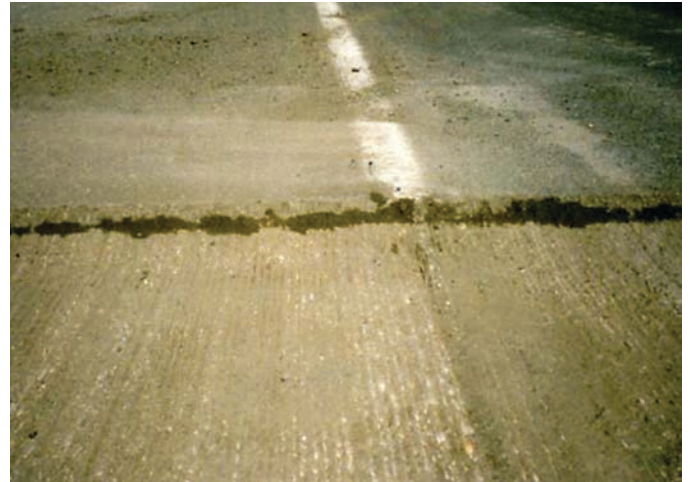
Figure 1.3. Moisture present at HMA layers interface.

Delamination can propagate more quickly if water is forced along the interface between two layers (Figure 1.3) by hydrostatic pressures imposed through trafficking (Khandal and Rickards 2001).

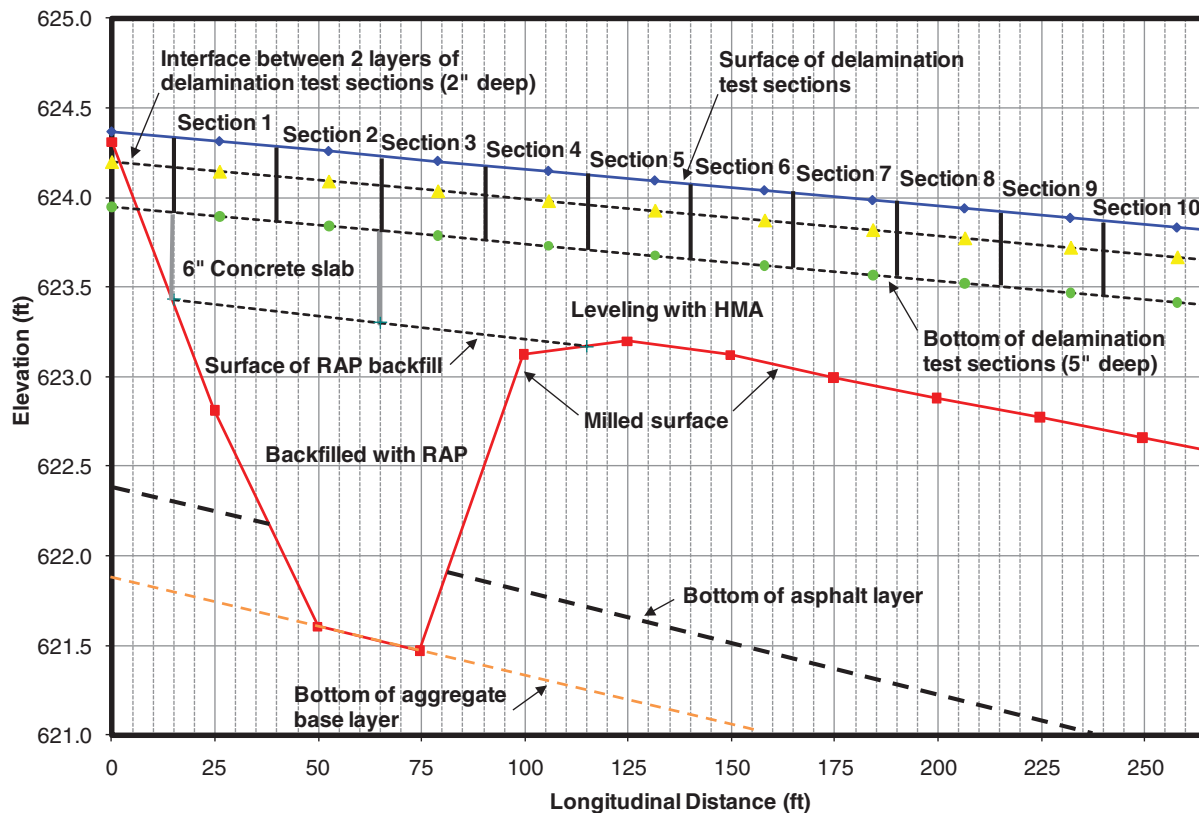
Figure 3.3. Pavement test section profile: Stations 0+00 to 2+65.

The 10 pavement test sections were built in the inside lane adjacent to Section N5 between Stations 0+15 and 2+65 (Figure 3.3). The old pavement section built between these stations was constructed in 2000 with a 24-in.-thick HMA layer on top of a 6-in.-thick aggregate base. Because of deep cracks between Stations 0+50 and 0+75, repairs were done before the construction of the delamination test sections. The asphalt and a portion of the aggregate base layers were milled at the beginning of the old pavement section. For the second half of the experimental section, the old asphalt layer was milled down approximately 6 in. to accommodate leveling and the delamination test sections. After the milling and backfilling work was completed, a 6-in.-thick concrete slab was constructed from Station 0+15 through Station 0+65. Layers of HMA leveling were paved from Station 0+65 through Station 2+65 to prepare the surface for the delamination test sections. The 10 pavement test sections, designed as described

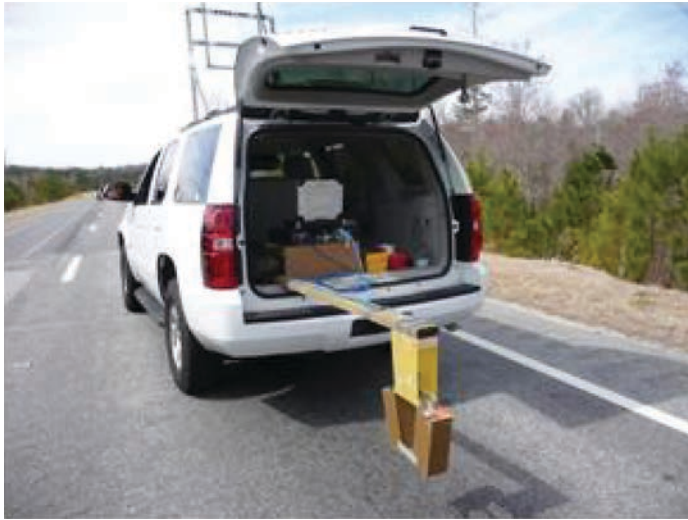
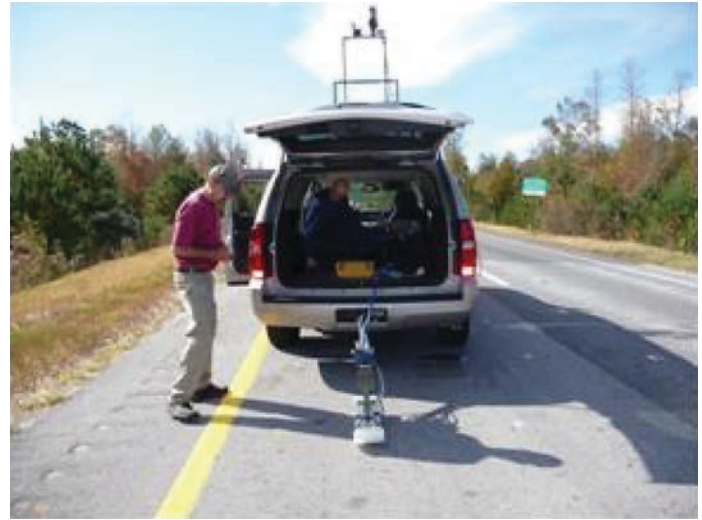
Figure 3.4. GSSI GPR equipment at NCAT Pavement Test Track: (a) prototype 3-GHz horn antenna and (b) 2.6-GHz ground-coupled antenna.

- A 3-GHz “horn antenna” (Figure 3.4a) and a 2.6-GHz “ground-coupled” antenna (Figure 3.4b) provided by GSSI. The GSSI system focused on the implementation of new high-frequency antennae that would have the resolution to detect the small changes associated with pavement delamination. The specific advantage of the horn antenna is that it is noncontact and can be used to survey a pavement at much higher speeds than can a ground-coupled antenna, which requires contact with the pavement. The horn antenna tested as part of this work was a prototype. The ground-coupled antenna is a currently manufactured product.
- A 1.3-GHz ground-coupled antenna array (MIRA) (Figure 3.5a) and a 2.3-GHz ground-coupled antenna (Figure 3.5b) provided by MALA AB. The MIRA system from MALA is a 16-channel array that has the advantage of obtaining greater

GSSI tested the 2.6-GHz ground-coupled antenna pair and the prototype 3-GHz horn antenna, and each system was deployed from a survey vehicle as shown in Figure 3.4. The first round of field testing evaluated both systems, but the second round of testing focused on the 3-GHz horn. The tests were carried out by using a series of parallel survey lines spaced initially at 1 to 1.5 ft apart and ultimately at 6 in. apart. Data were collected at rates ranging from 4 to 12 scans/ft. The position of the data was registered by using a distance encoder mounted to the wheel of the test vehicle. Data collection speed ranged from 3 to 5 mph. The 2.6-GHz ground-coupled antenna pair was placed end-to-end on a skid plate, while the horn antenna was suspended about 12 in. above the

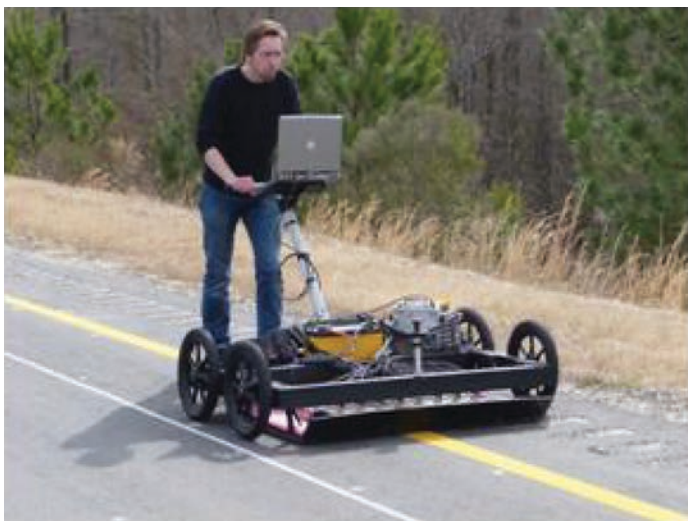
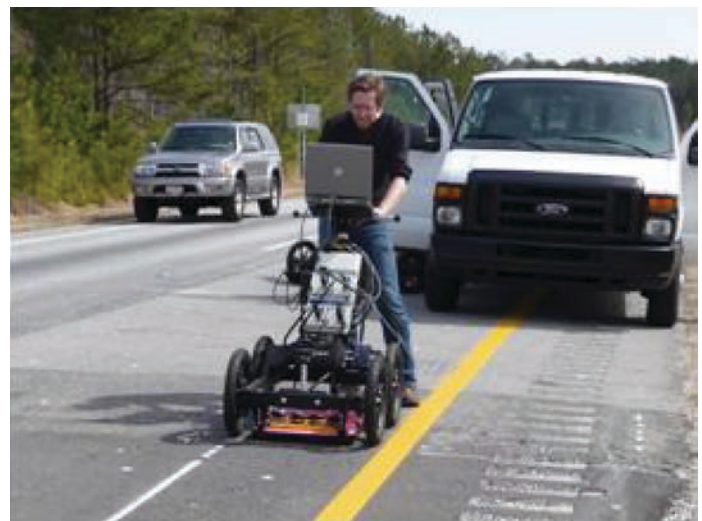
Figure 3.5. MALA GPR equipment at NCAT Pavement Test Track: (a) 1.3-GHz ground-coupled antenna array (MIRA) and (b) 2.3-GHz ground-coupled antenna.

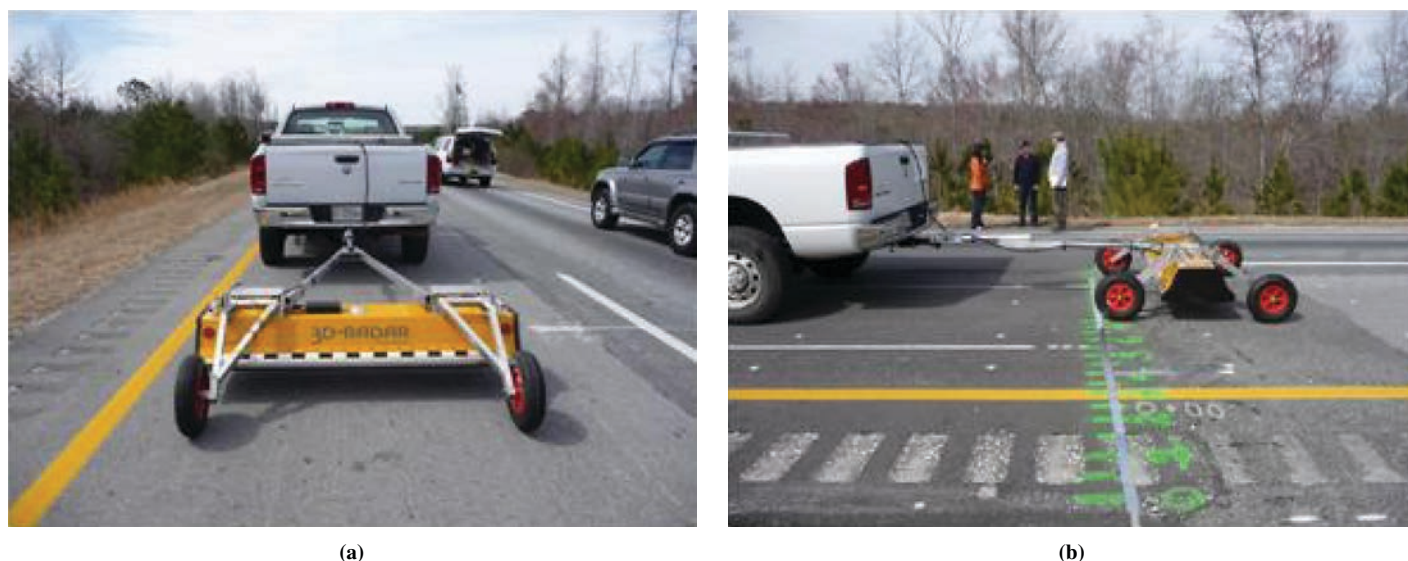
Figure 3.6. 3d-Radar swept frequency (150 MHz to 3 GHz) noncontact array: (a) rear view and (b) side view.

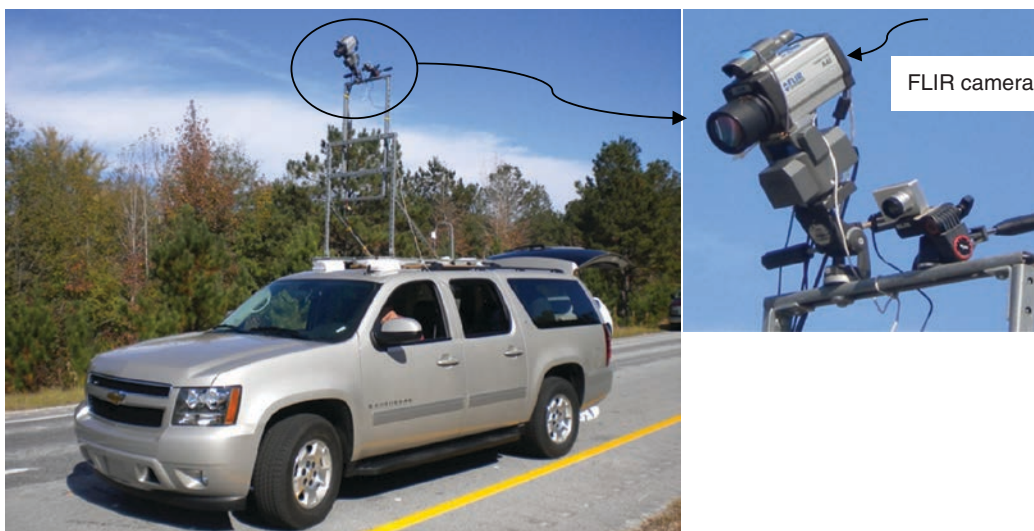
Figure 3.11. Infrared thermography setup for testing at the NCAT Pavement Test Track.

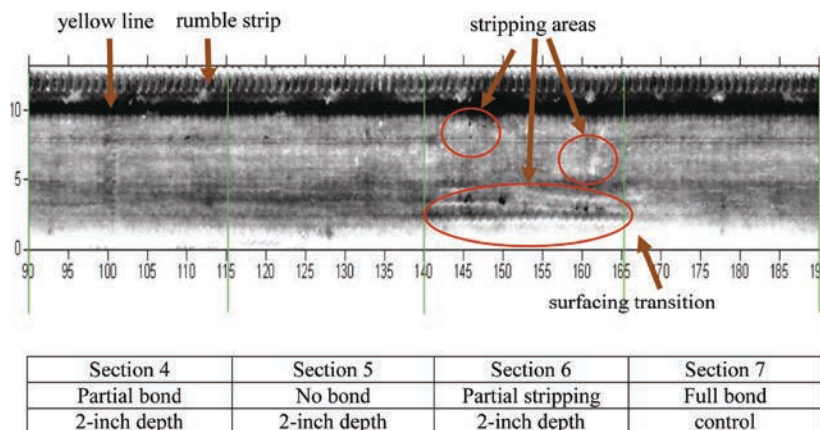
Figure 3.12. Infrared strip image of Sections 4 through 7.

Figure 3.12 shows an example of the analysis of the IR data. The figure shows a portion of the composite IR image representing Sections 4, 5, 6, and 7 at the test track. The image shows some anomalies in Section 6 in the area where 0.75 in. of RAP was placed 2 in. down from the surface to simulate stripping. However, examination of the surface video shows those anomalies to correspond with surface features

and tire marks, rather than subsurface features. In general, the IR image anomalies did not clearly correlate with the known subsurface defects placed in the test sections.

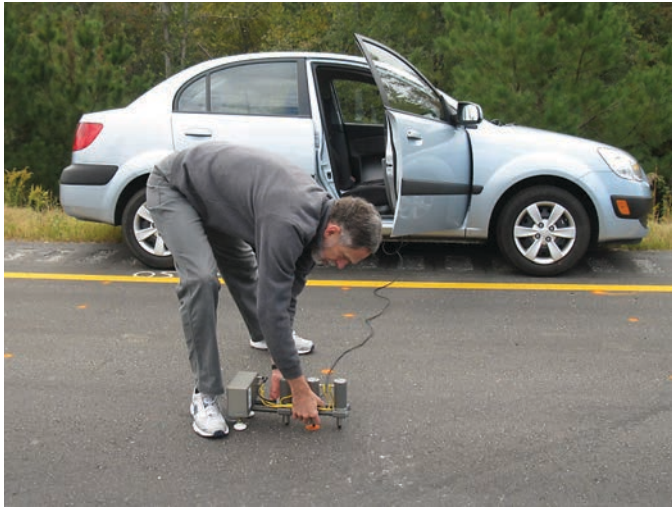
Figure 3.13. PSPA Testing at NCAT Test Track.

receivers and the source. The source strikes the pavement surface and generates stress waves that are detected by the receivers. The measured signals are returned to the data acquisition board in the computer. The system measures the velocity of the propagated surface wave and computes the material modulus. Testing duration is typically 1 min per test. This duration includes three test replicates at one location.

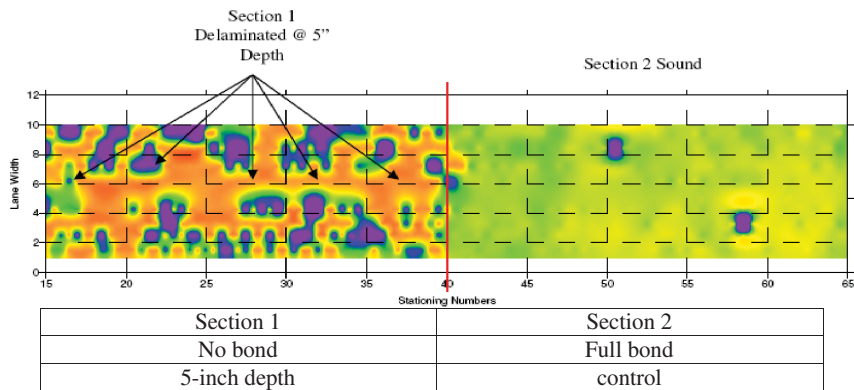
Figure 3.16. Scanning IE thickness plots for Sections 1 and 2.

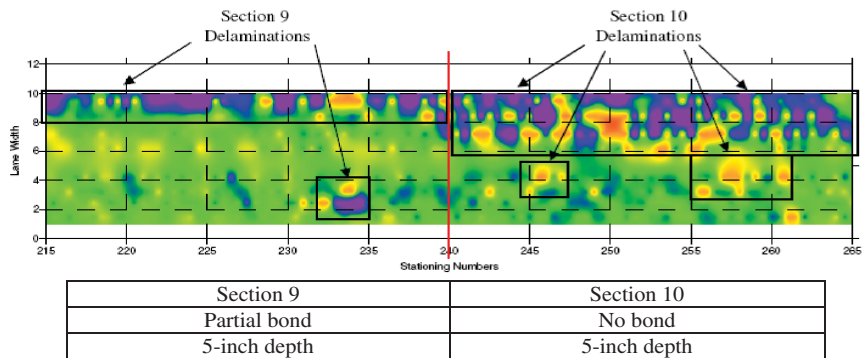
Figure 3.17. Scanning IE thickness plots for Sections 9 and 10.

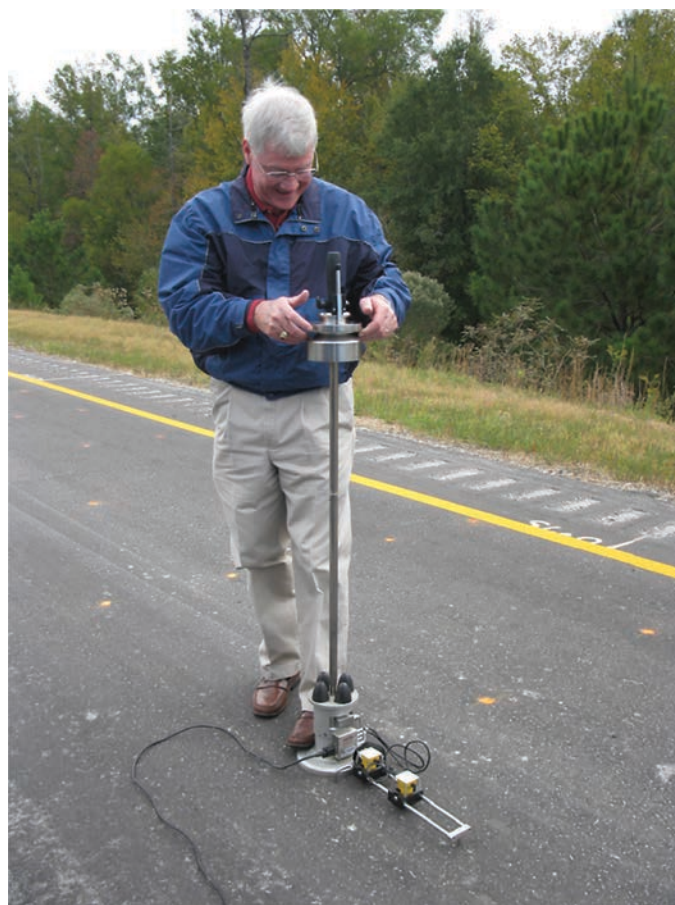
Figure 3.18. LWD testing at NCAT test track.

LWD is an NDT device that provides a structural evaluation of pavements by using a drop weight and one to three sensors (D1, D2, and D3) (Figure 3.18). The drop weights for the LWD are selected from 22, 33, or 44 lb. The loading plate diameter can be adjusted to 3.8, 7.8, or 11.8 in. The height of the drop is adjustable. The weight is dropped onto a rubber buffer located on top of a load cell. The results are presented as a plot of the time history of the measurements from the load cell and the geophones. Peak deflection and surface deflection measurements of each sensor are recorded.

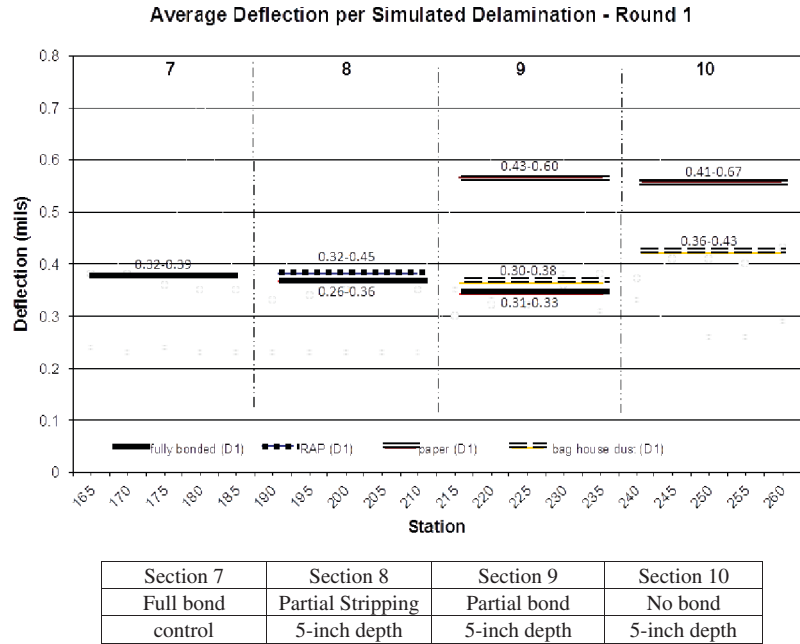
Figure 3.20. Round 1 average deflections of each delamination type (Sections 7 through 10).

As shown in Figure 3.20, the fully bonded areas provided similar deflection measurements to those areas with RAP and baghouse dust. Simulated debonding using paper had much higher deflections compared to the baghouse dust, RAP, and fully bonded areas. It seems that using the paper created a loss in bond and possibly some loss in friction between the two layers, while the baghouse dust may have resulted in a higher bond than when the paper was used. The higher measured deflections with paper may have been an indication of loss of friction between the layers under loading, resulting in more relative movement at the interface between the two layers. As the load from the LWD was applied, the HMA layers were able to slide along the paper, resulting in increased movement and deflection. Some friction most likely existed within the

delaminated areas simulated with baghouse dust because of the texture provided by the baghouse dust.

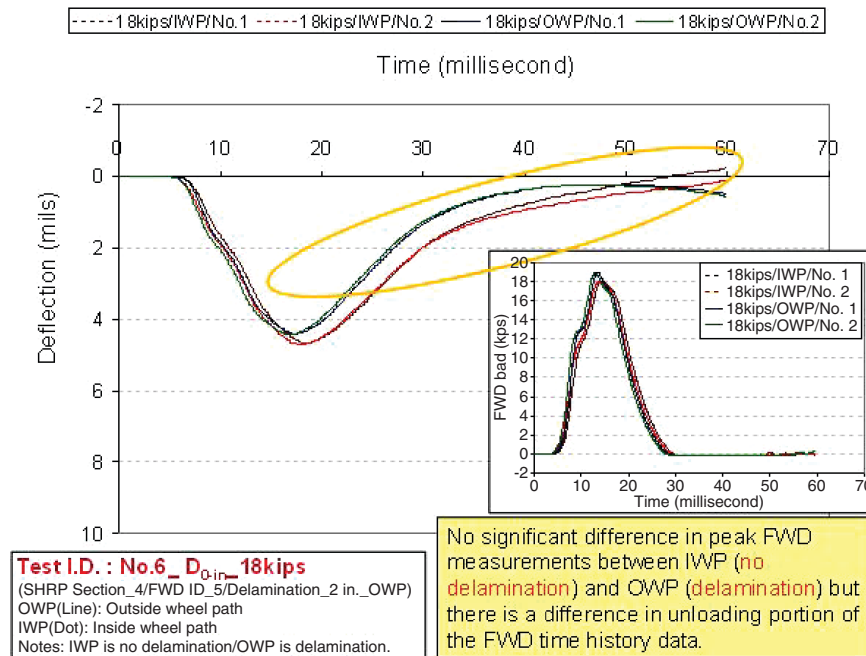
Section 4 – partial bond at 2-in. depth (OWP no bond, IWP partial bond)

Figure 3.21. D_0 Time history under 18-kip loading for FWD Test 6 in Section 4.

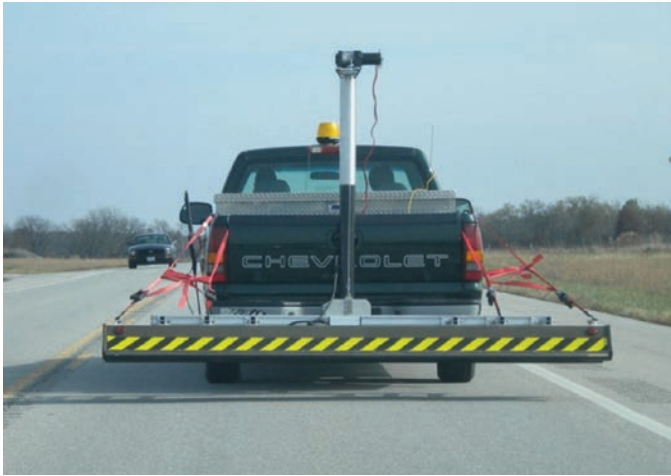
Figure A.1. Example of full lane width GPR antenna array.

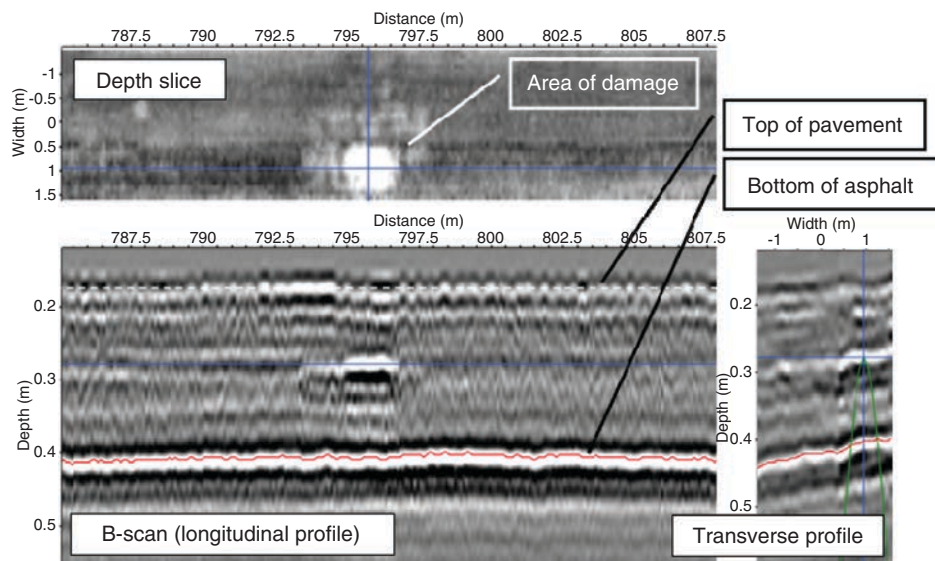
Figure A.2. Sample display of data.

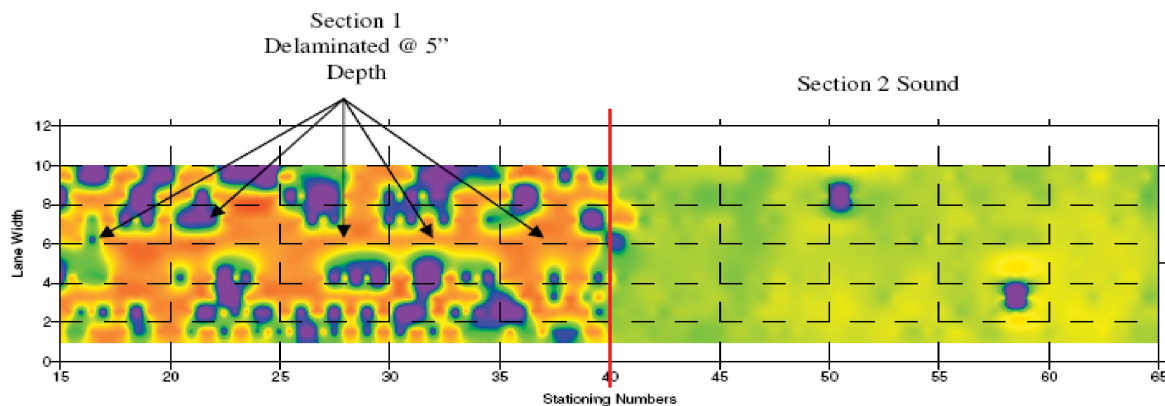
Note: dark blue/cyan areas = anomalously high thicknesses; light green = expected AC thickness.
