## Risk Assessment of Proposed ARFF Standards

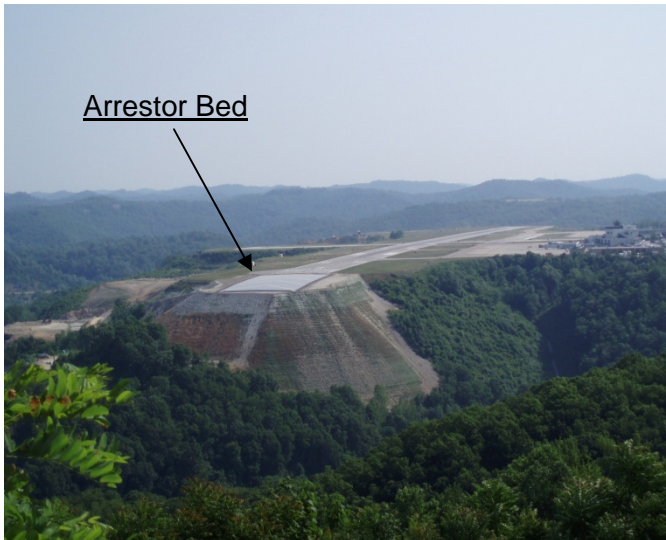
The latest challenge was how to accommodate the Federal Aviation Administration's requirement for a safety area on each runway end. Normally the safety area is a

cleared, graded area that extends 1000 feet beyond the runway end and 250 feet on either side of the extended centerline. To construct a safety area of these dimensions at Yeager Airport would have been exorbitant. Instead the airport operator chose to extend the existing safety area at the departure end of runway 23 from 120 feet to 460 feet in length. It then installed a passive arresting system consisting of cellular cement on 405 feet of this newly graded area. Although it was expensive, this was a relatively cheap solution compared to the

standard runway safety area. This project was completed in September 2007.

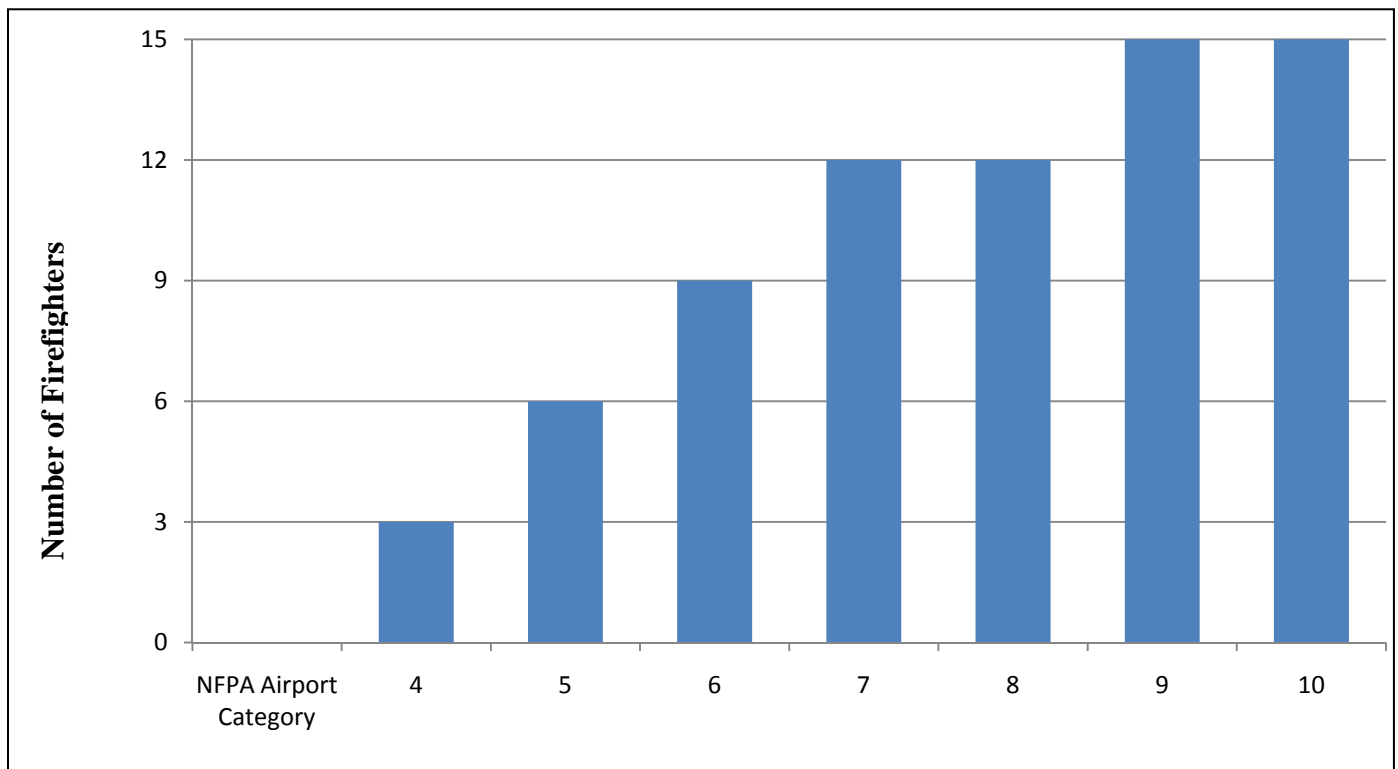
**Figure 1. NFPA 403 Minimum Number of Firefighters per Shift**

NFPA, on the other hand, does publish a minimum staffing requirement based on the category of airport. Annex D to NFPA 403 contains an explanation of how NFPA developed its staffing figures. Basically, it is based on a Task and Resource Analysis Model that was used to determine the minimum number of qualified personnel required to deal with an aircraft accident or incident. Figure 1 shows the staffing required by the NPFA.

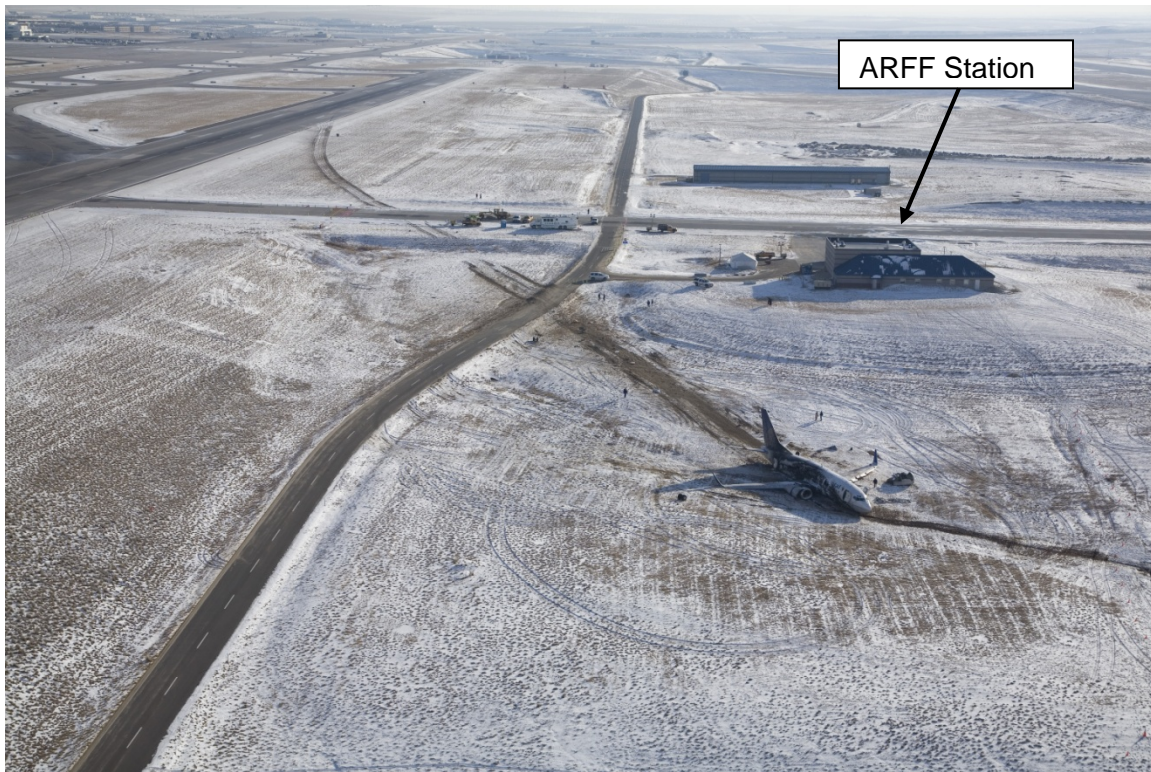
One of the best examples of the differences between "demonstrated" and "actual" response times is illustrated by an accident that occurred at Denver International Airport (12/20/08, KDEN). During takeoff in the early evening hours, a Boeing 737 veered off the runway and came to rest approximately 100 to 200 yards behind an ARFF (see photo). The controller initially provided the wrong information on the accident location and failed to properly reset the notification system when he attempted to correct the location information. The vehicle from one of the ARFF stations exited the station towards the initially reported location without seeing the accident located right behind the station. By the time the ARFF units received the correct location information and reached the aircraft, it was ablaze. Fortunately, everyone on board had already evacuated. Incidentally, ARFF units from another station on the airport were the first to reach the accident site.

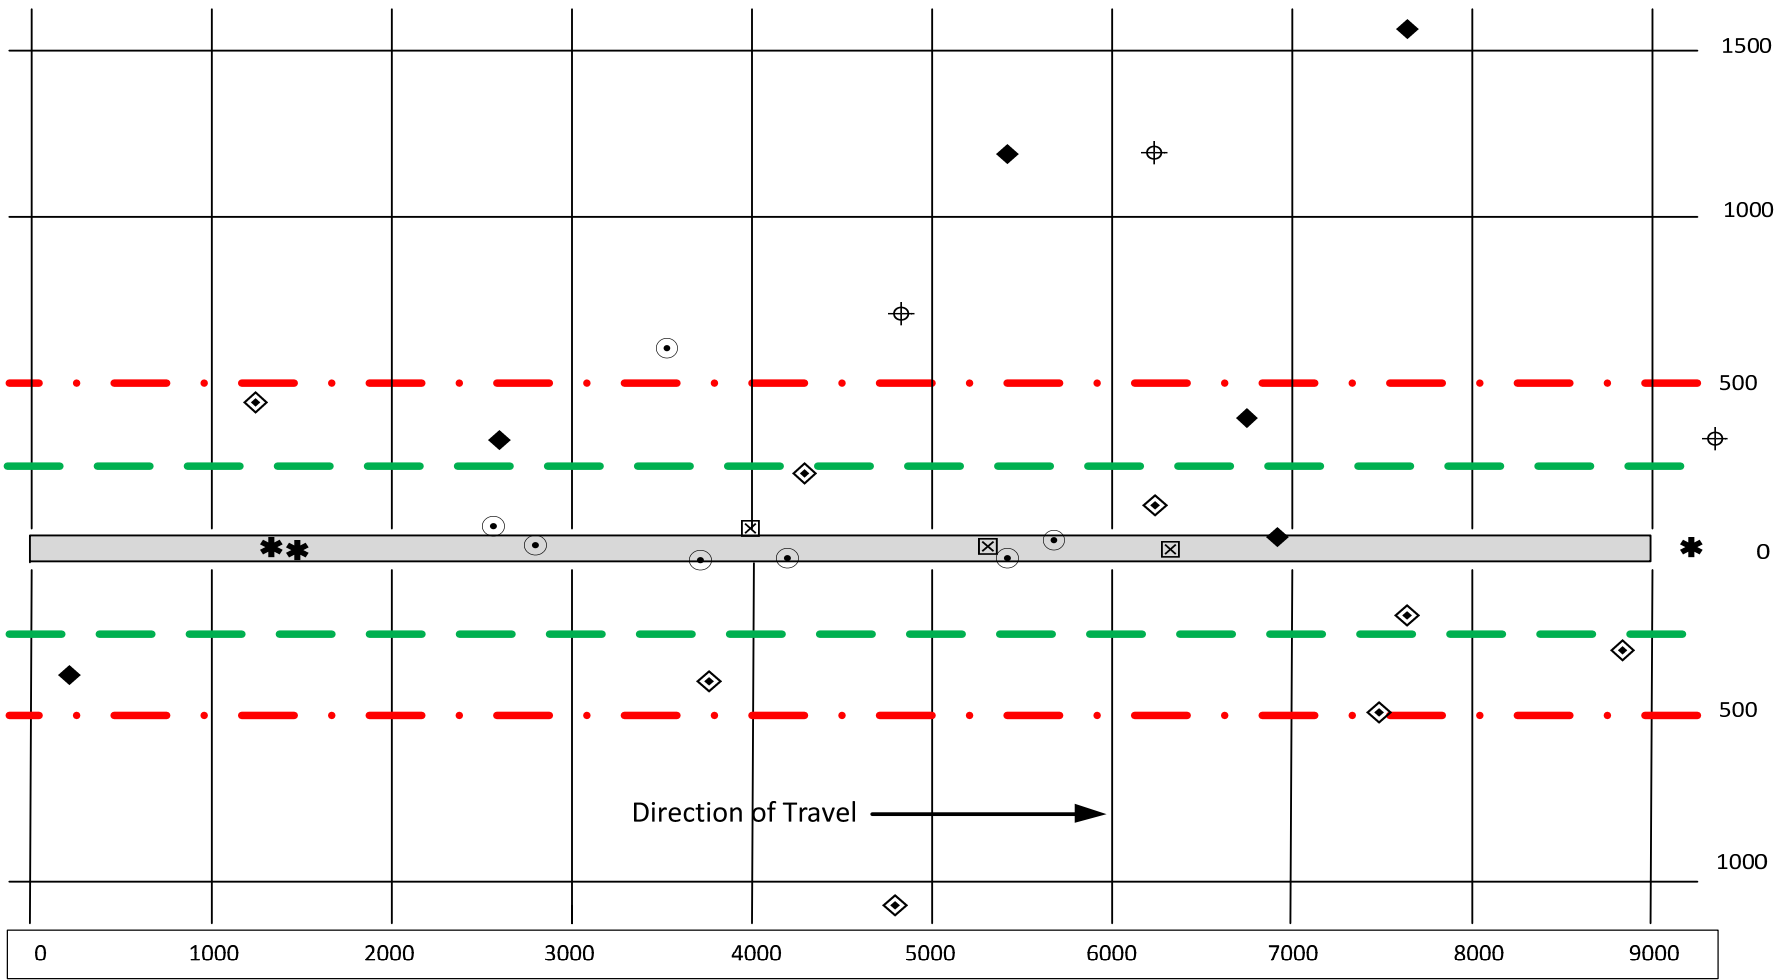
Figure B-2 Accidents on or Abeam the Runways

| ◇ Landing – Veer Off | * Takeoff – Remain on runway | — — — Runway Safety Area |
| ⊙ Runway Collision | ◆ Other | |
